Submerged Cultural Resources Site Report

CHARLES H. SPENCER
MINING OPERATION AND
PADDLE WHEEL STEAMBOAT

GLEN CANYON NATIONAL RECREATION AREA

Southwest Cultural Resources Center Professional Papers
Number 13

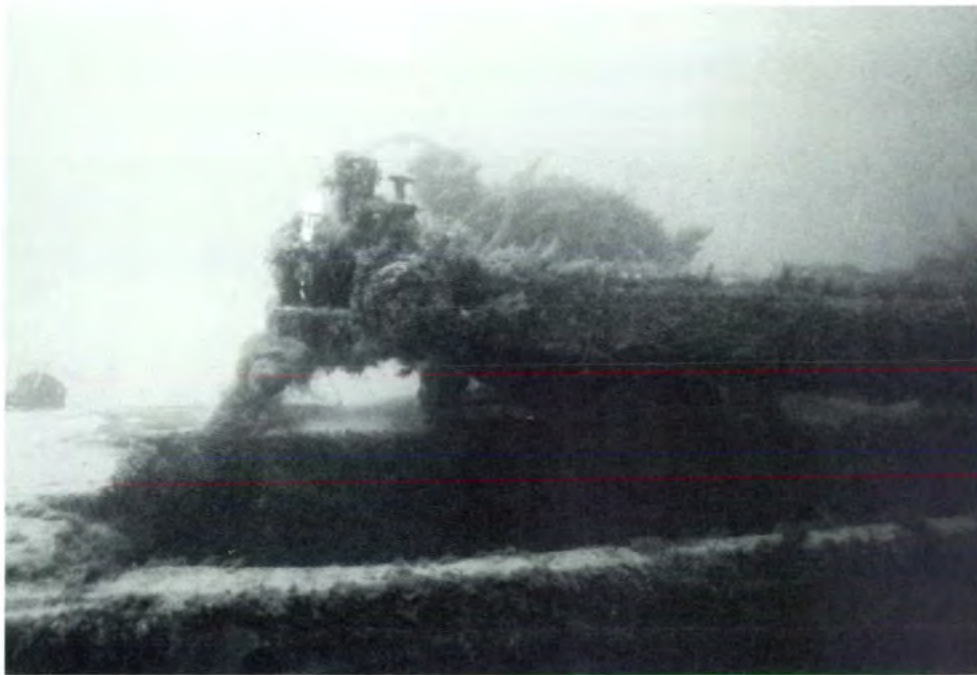
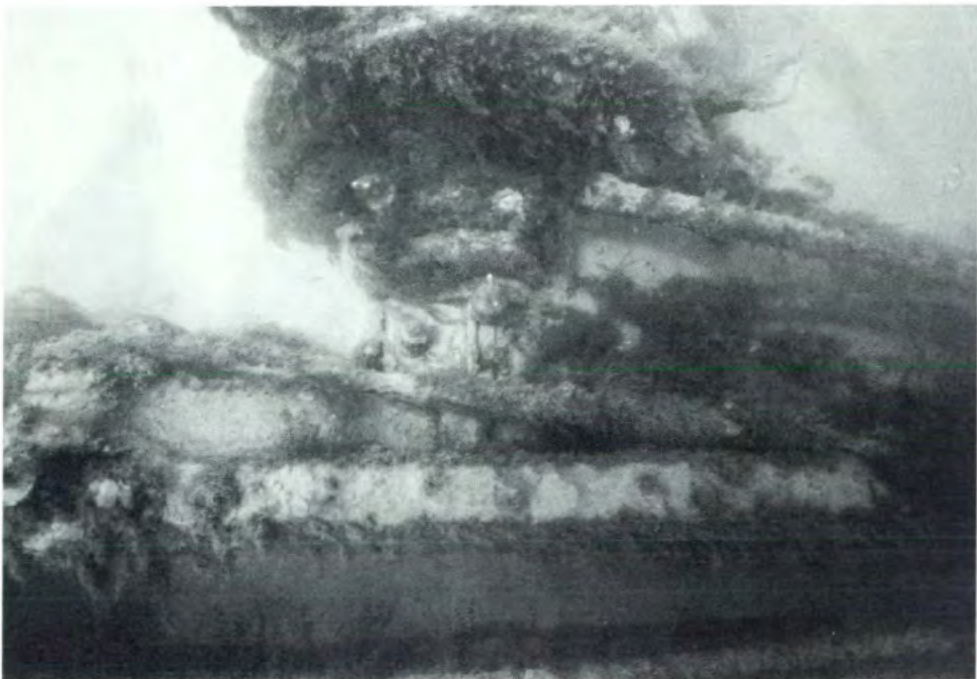
Figure 7.11 Profile view of pitman, pitman jaws, cylinder timber, and crank (top). Plan view of pitman, eccentric rods, crank, pillow block and cap, and paddle wheel hub (bottom). Photo by T. Carrell.

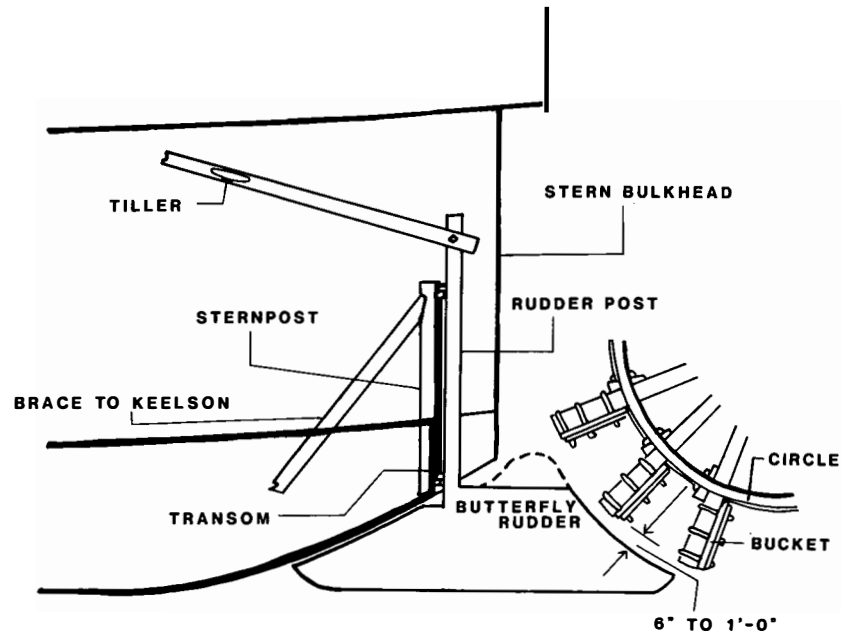
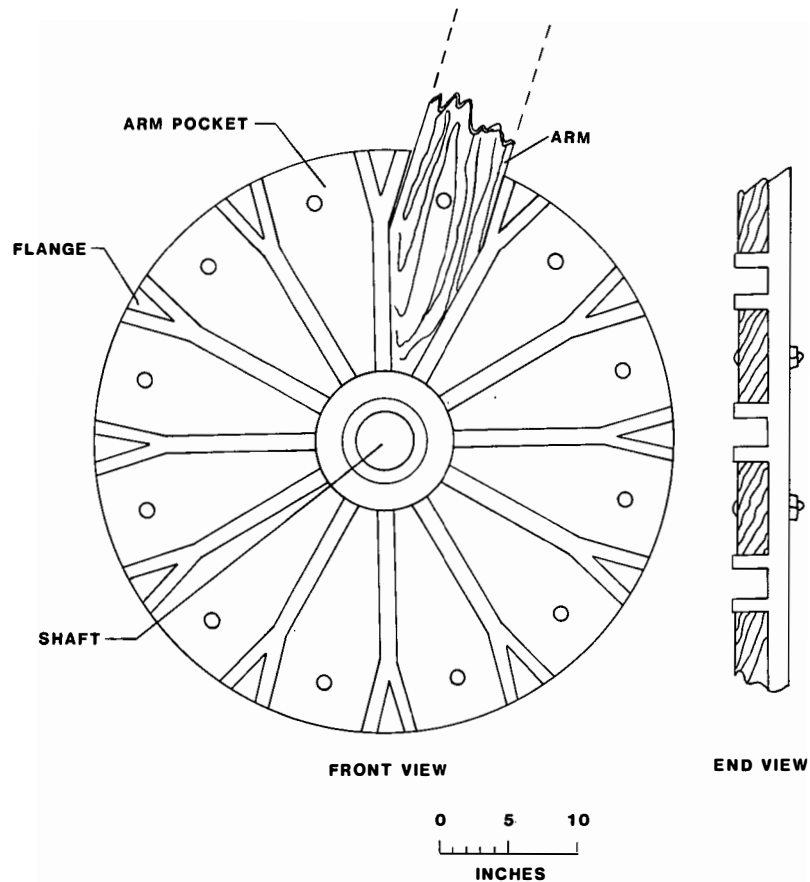
Figure 7.12 Typical arrangement of paddle wheel, rudder and transom on sternwheeler (top). The paddle wheel arms were strengthened by an iron-reinforced wooden circle. Detail drawing of CHARLES H. SPENCER's paddle wheel hub (bottom).

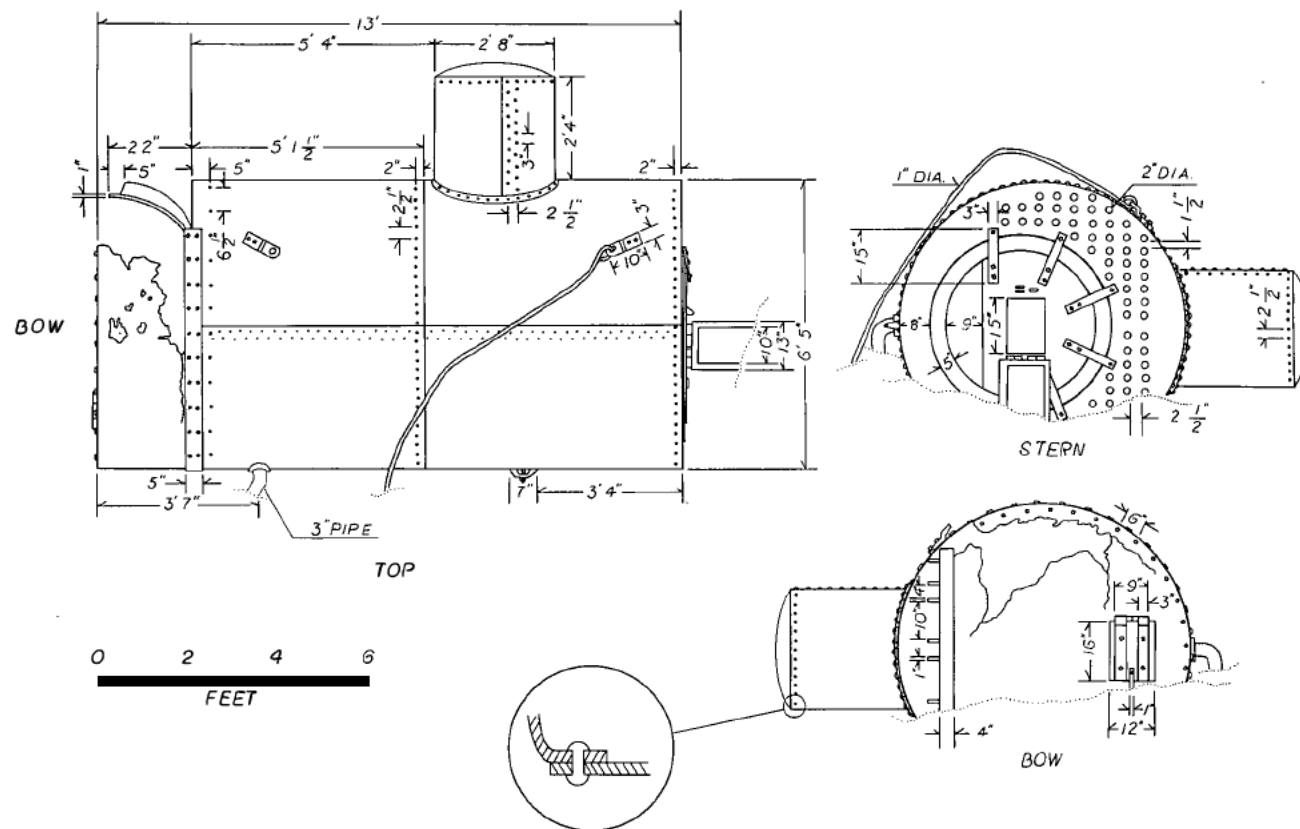
Figure 7.13 Detail drawing of boiler on CHARLES H. SPENCER.

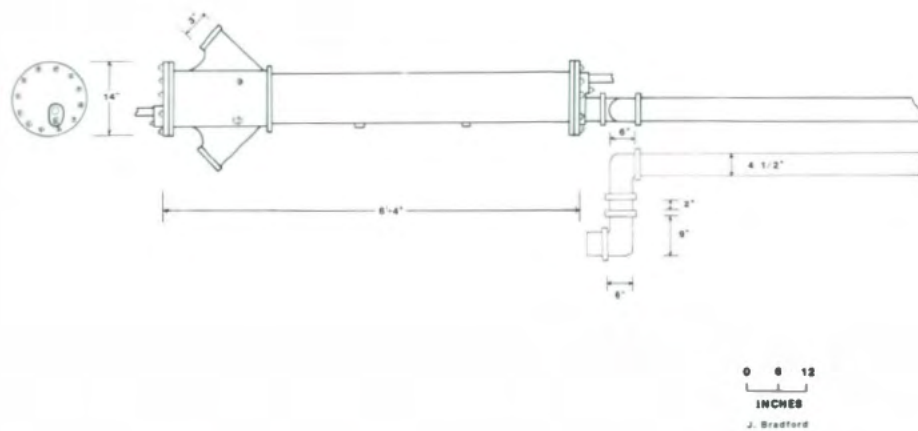
Figure 7.14 Detail drawing of heater with plan and profile views.

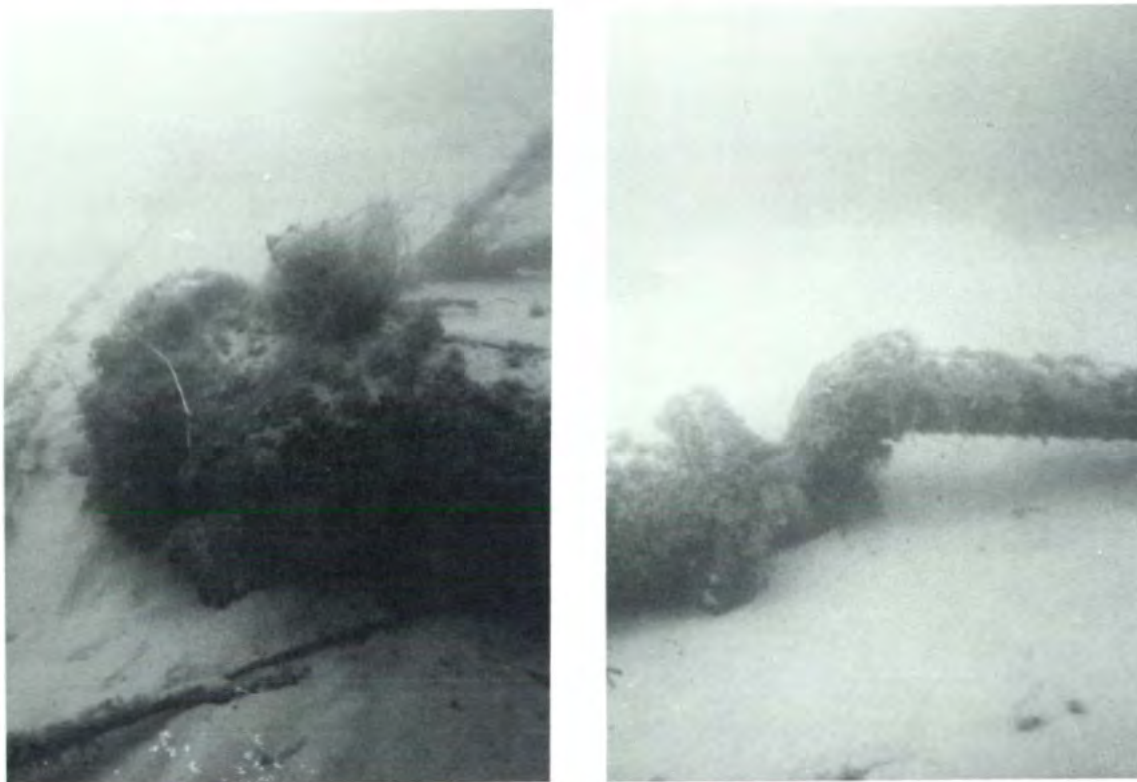
Figure 7.15 Heater head showing connections to steam pipes from engines (left). Heater exhaust with double reverse elbow attached (right). Photo by T. Carrell.

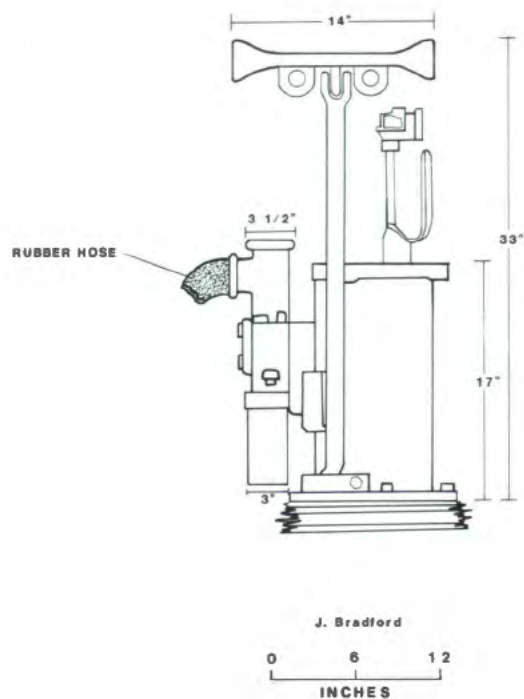
Figure 7.16 Detail drawing of hand-operated bilge pump.

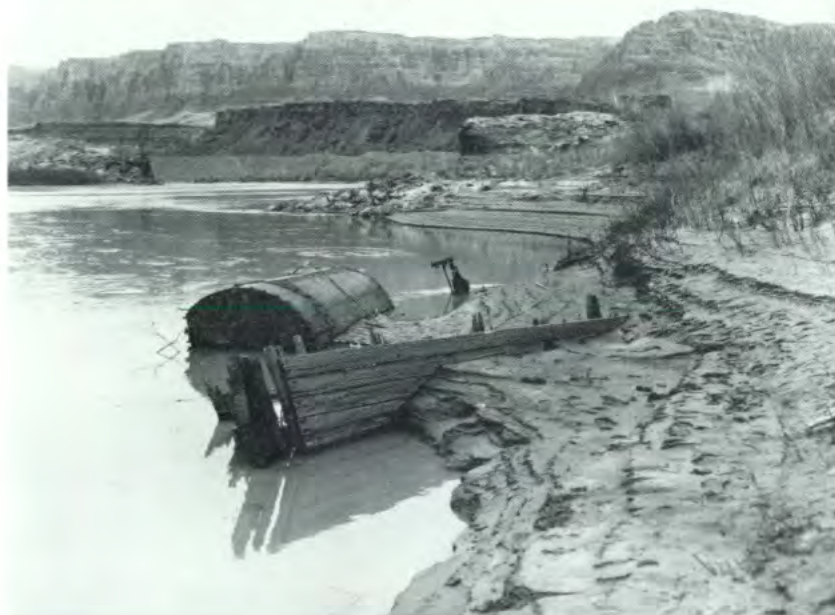
Figure 7.17 Condition of the boiler and the bilge pump in situ, March 1962. Photo by W. L. Rusho.

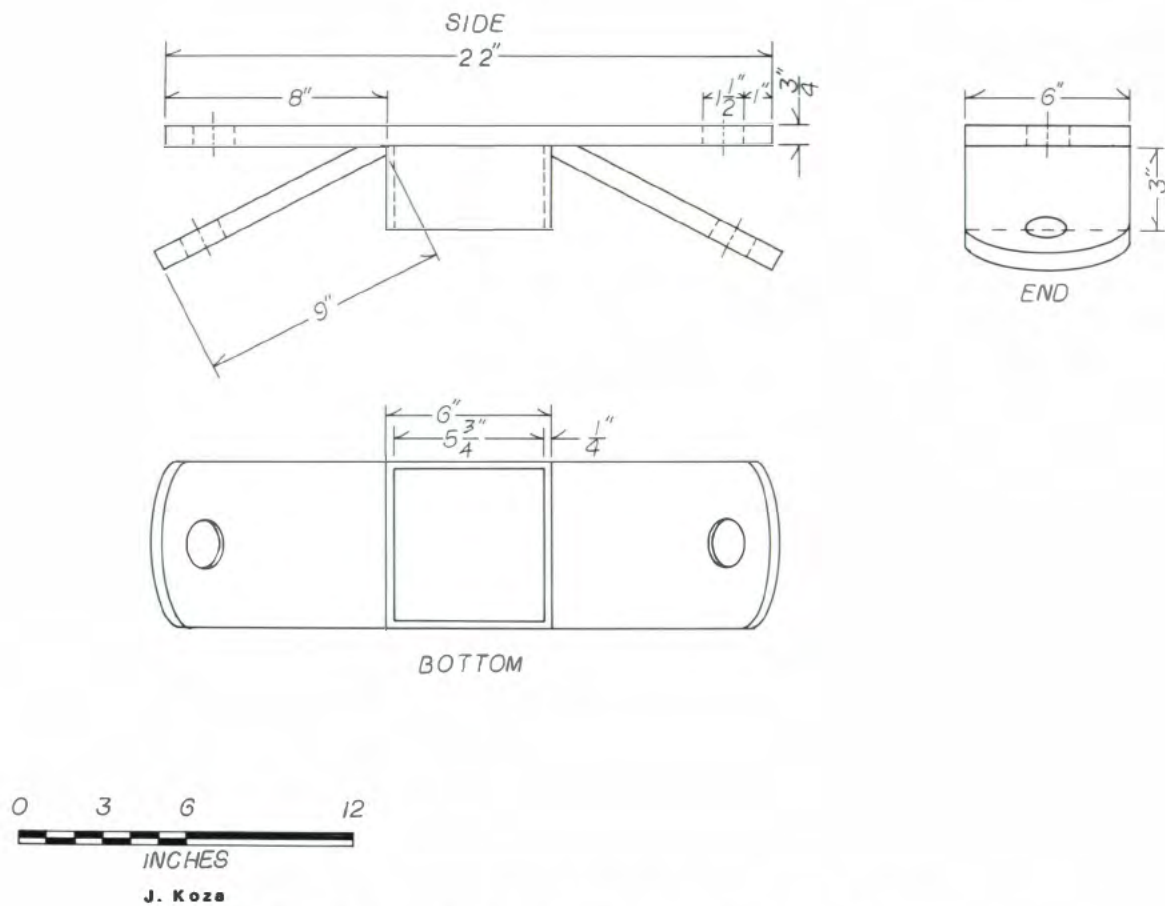
Figure 7.18 Detail drawing of samson post cap.

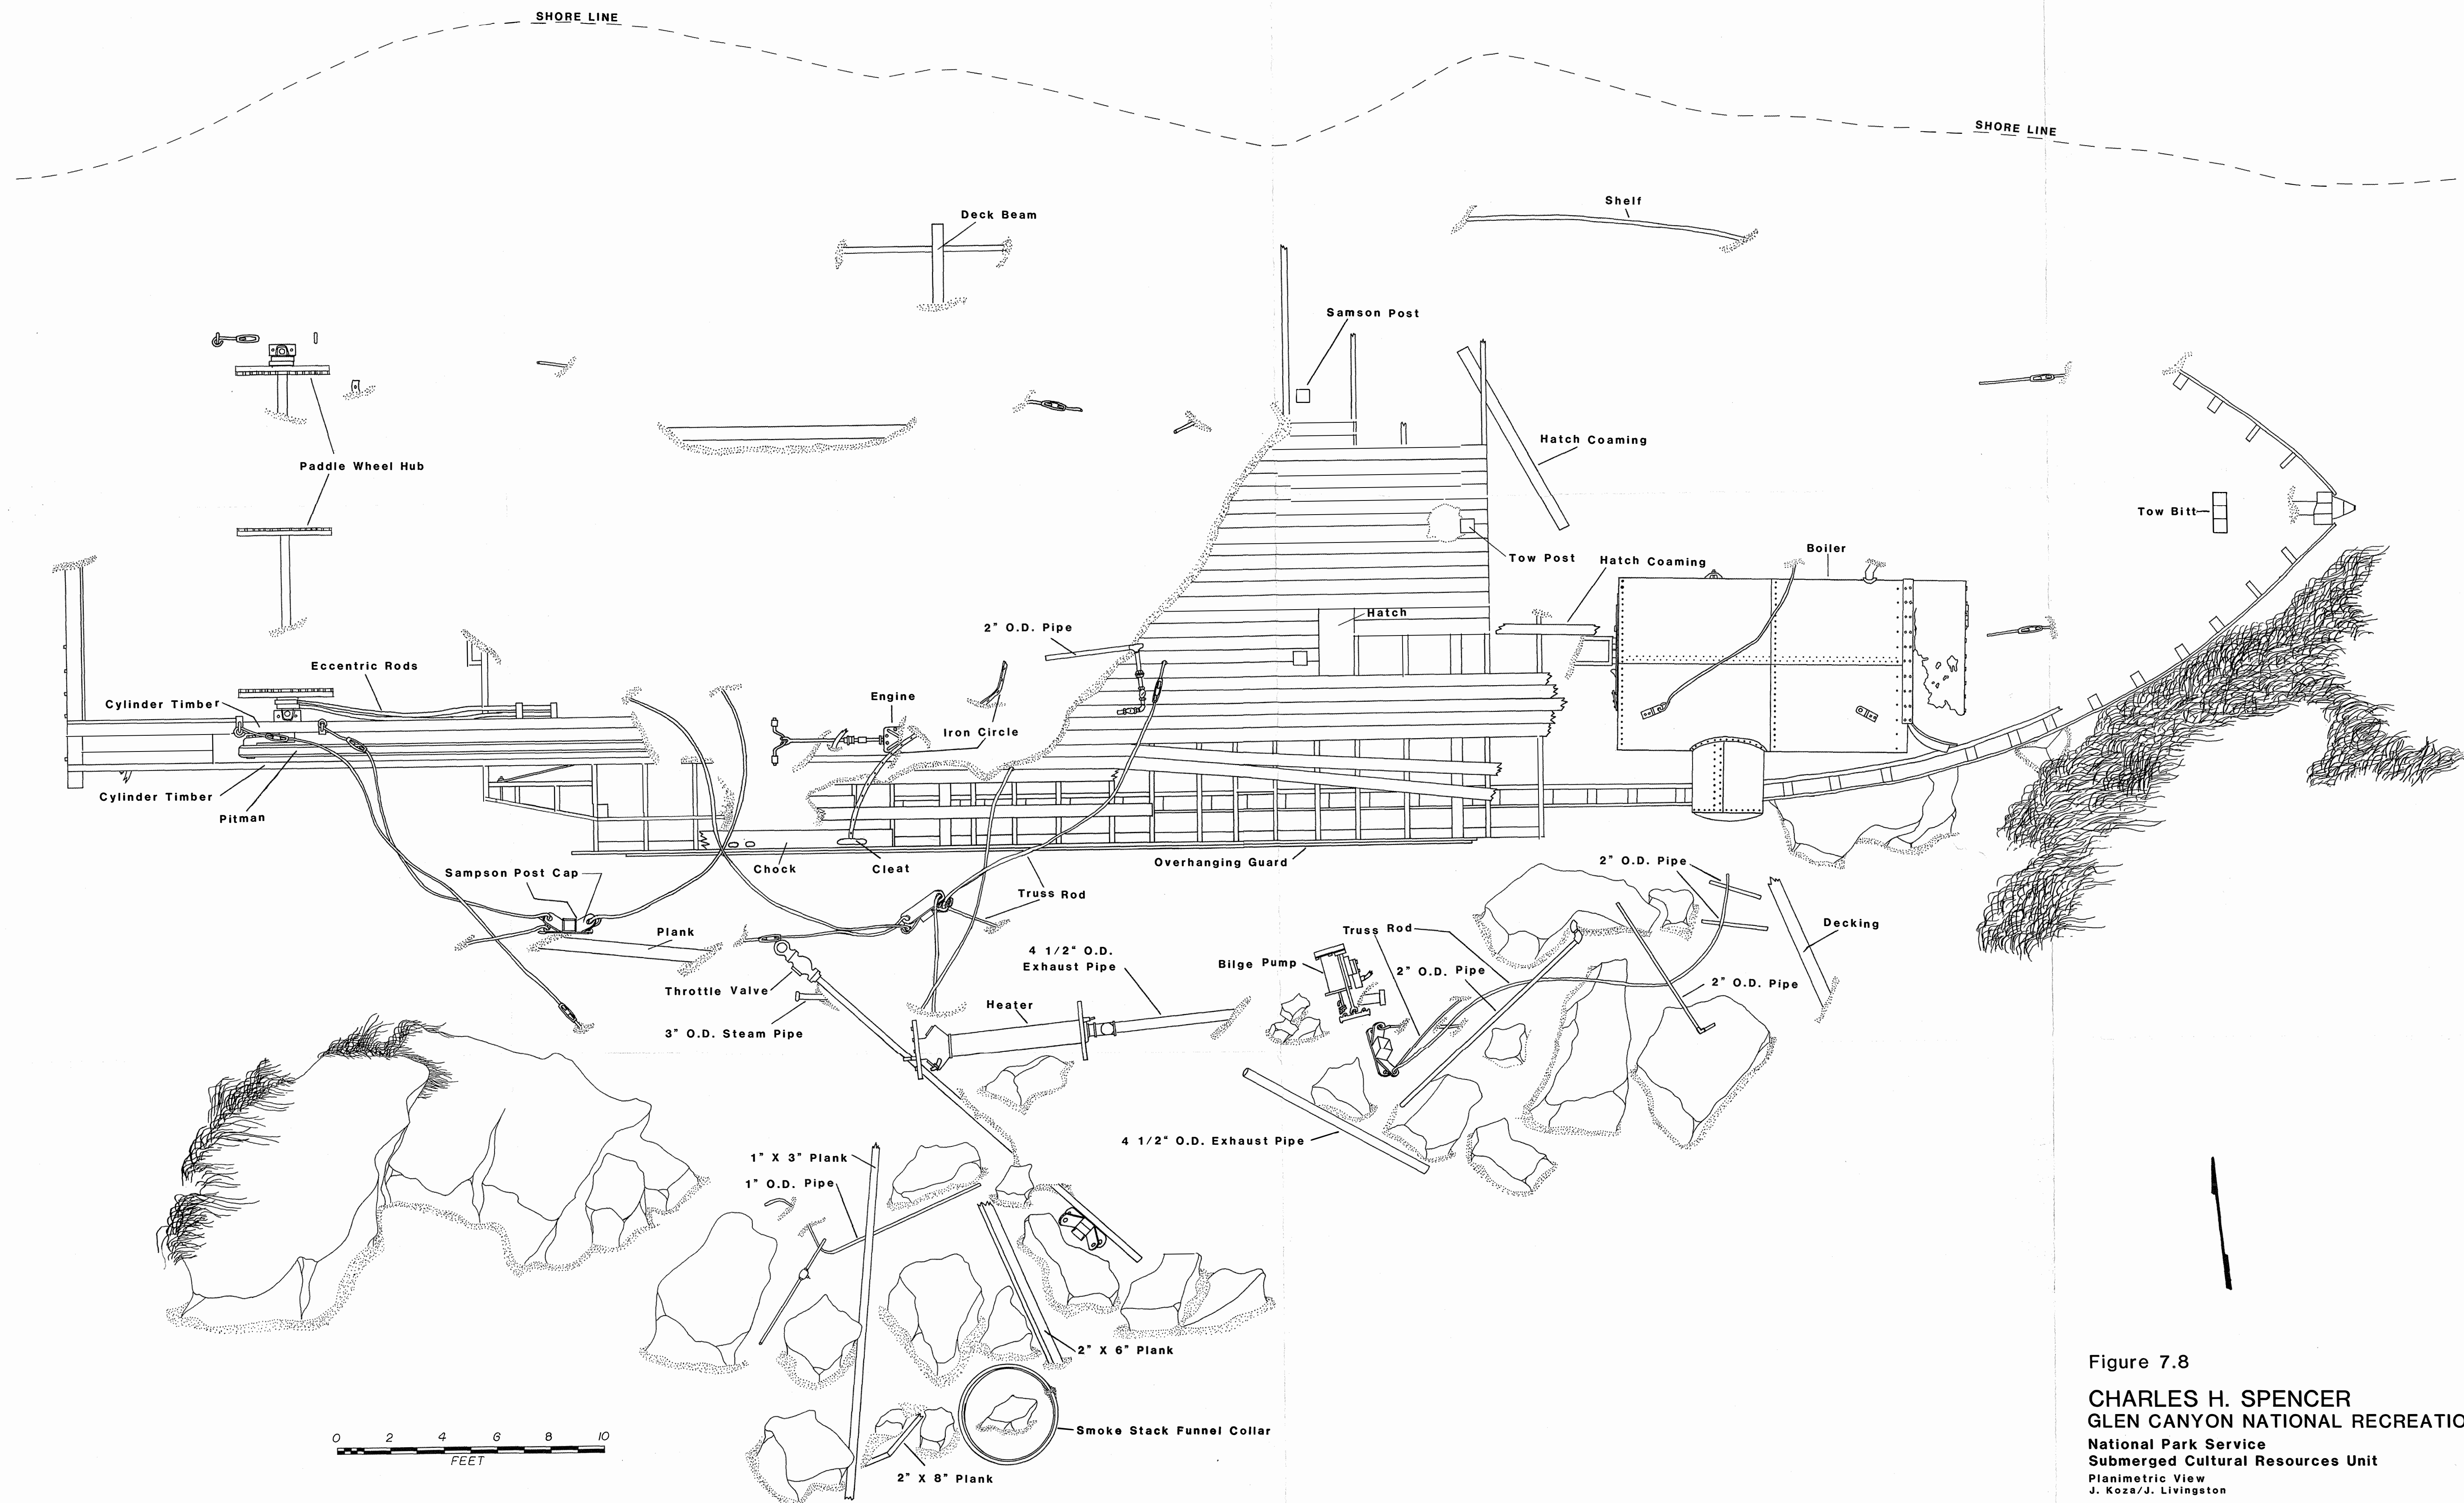
Figure 7.8
CHARLES H. SPENCER
 GLEN CANYON NATIONAL RECREATION AREA
 National Park Service
 Submerged Cultural Resources Unit
 Planimetric View
 J. Koza/J. Livingston
